# Information on the change of torque for screws of the ONE-SIXTY and ONE-FORTY

12.06.2023

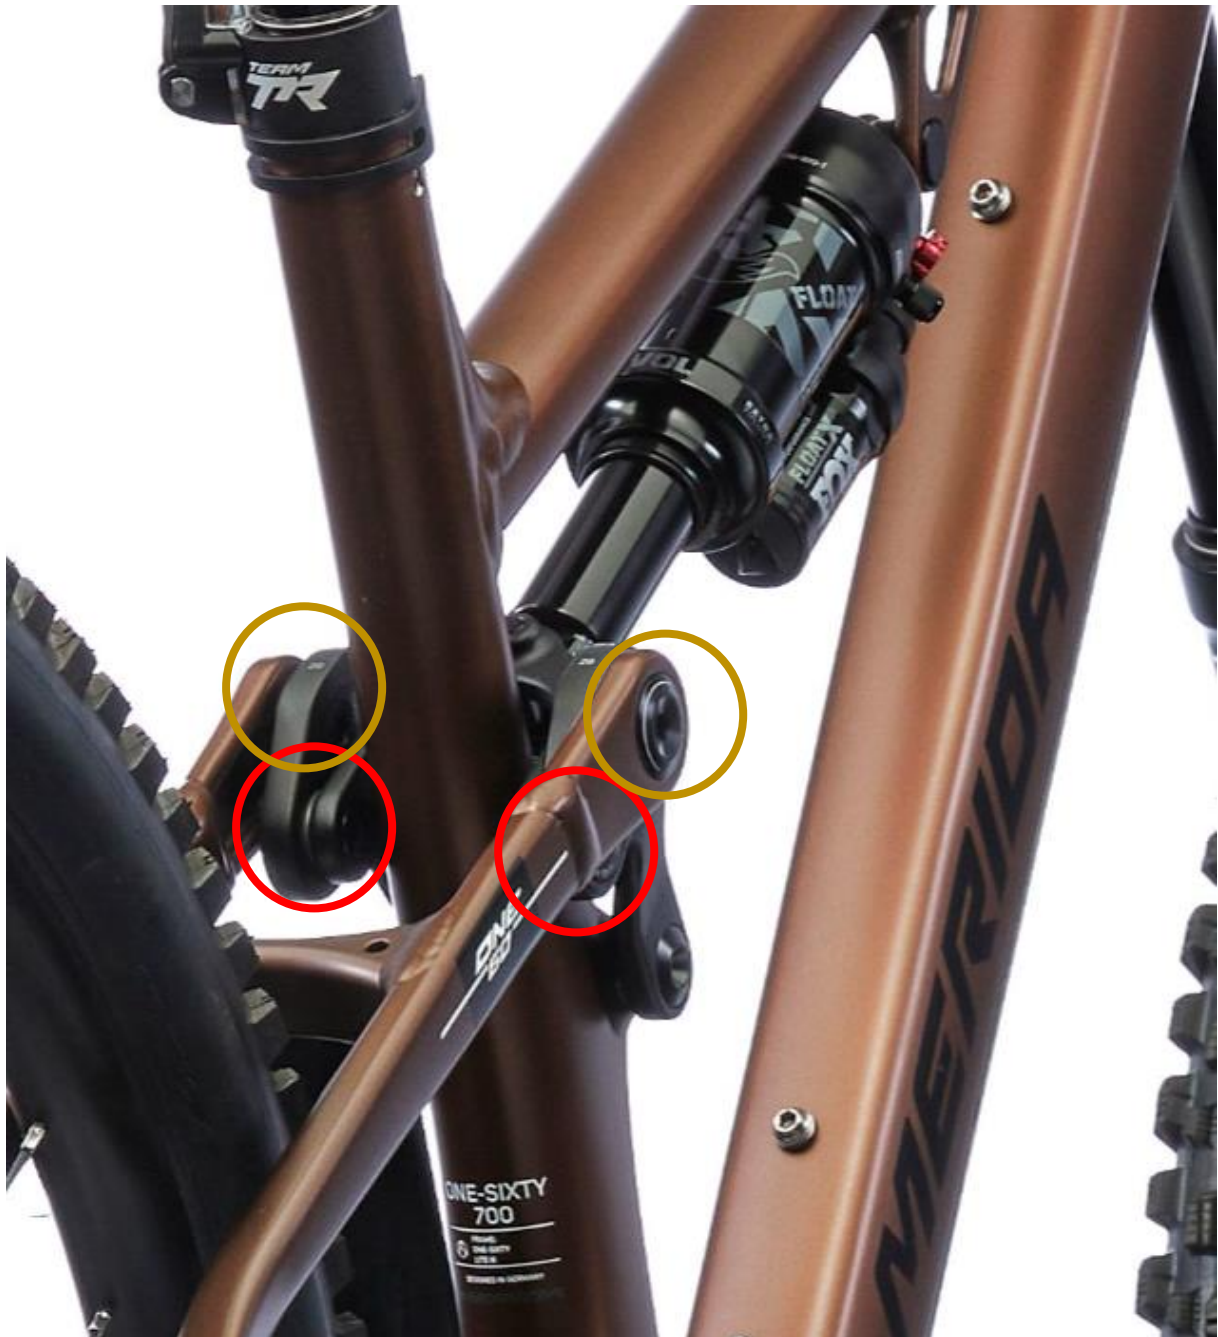
The torque of the screws which connect the rocker with the shock extension (highlighted red below, Nr. 10 [explosion drawing](#)) will be changed from 13-15 Nm to **23-25 Nm**.

Also, the torque of the screws, which connect the seat stay with the rocker (highlighted yellow below, Nr. 17 in the [explosion drawing](#)) will be changed from 13-15 Nm to **23-25 Nm**.

**have to increase the torque of the rocker on the delivered bikes to 23-25 Nm.**

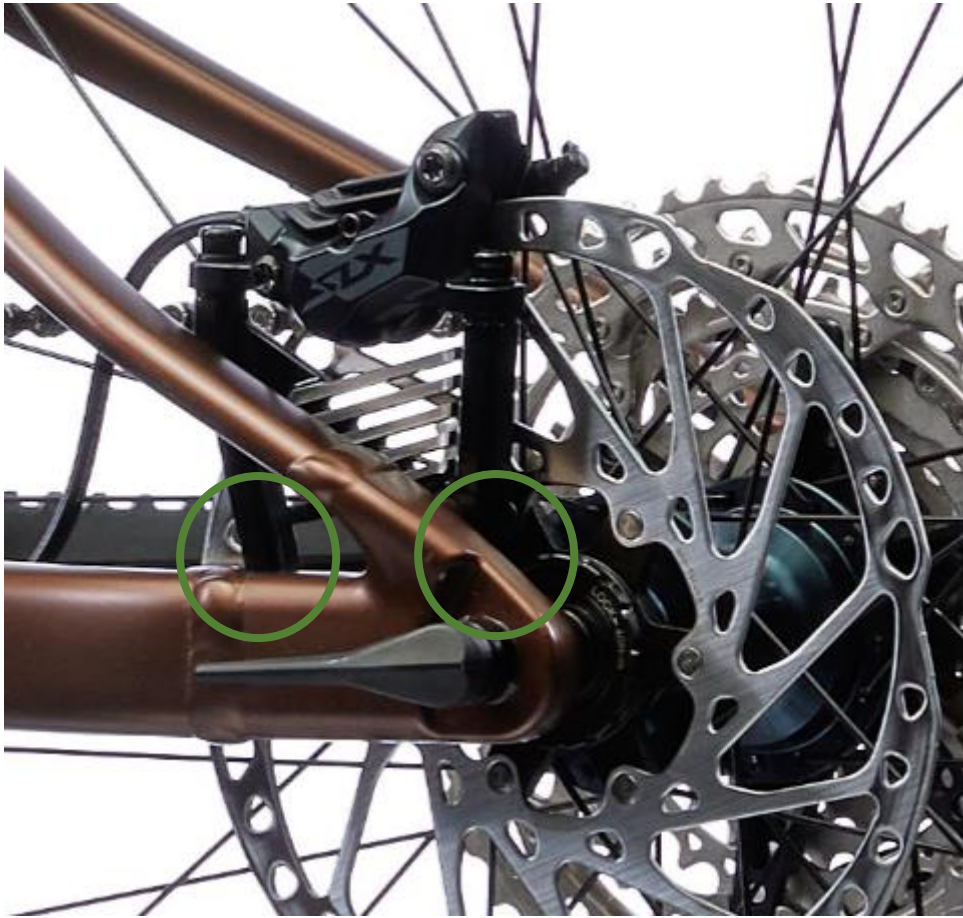
Please also note, that we have increased the torque recommendation of the three brake adapter screws (marked green below, Nr. 17 in the [explosion drawing on the right side](#)) from 6-8 Nm to 11-12 Nm.

**Also check these screws and the brake mount screws from time to time.**
